Manhole Inspection Summary

Manhole # S25M__040MH

Insp Date: **3/7/08 10:16 AM**

Location Address: **1185 West Ostend**

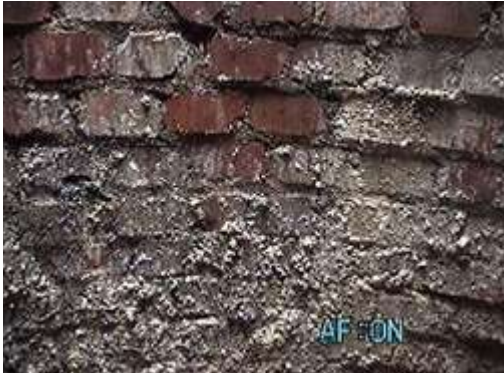
Defect 3

Infiltration: ☐ None ☐ Joint ☐ Cracks ☐ Mortar ☐ Roots ☒ **Wall**

evidence of infiltration in corbel and from chimney

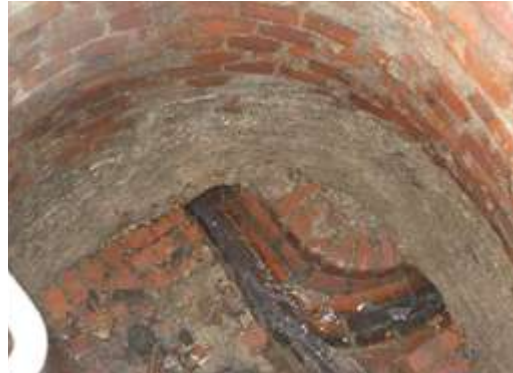
Defect 2

Infiltration: ☐ None ☐ Joint ☐ Cracks ☐ Mortar ☐ Roots ☒ **Wall**

evidence of infiltration in barrel

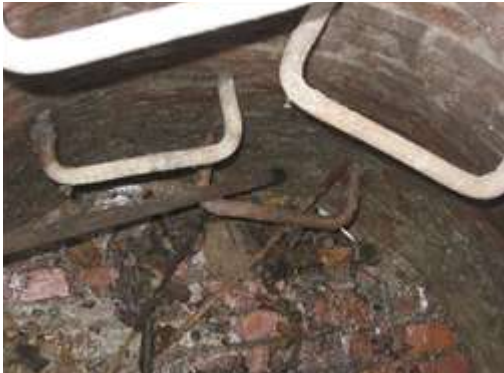
Defect 1

Count: **4** Missing: **0** ☒ **Corroded**

corroded stairs, debris at the bottom of MH

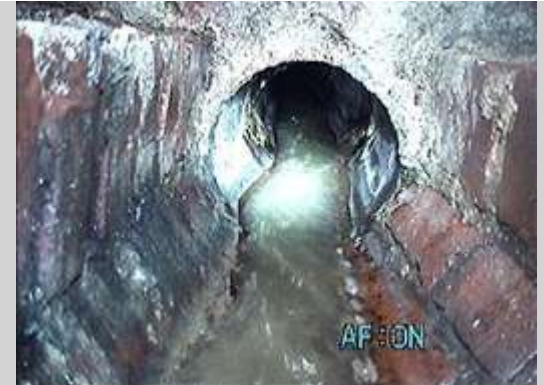
12 O'Clock Outflow

Pipe Height: **8.4** (in.) Rod and Bar (Angled)
Pipe Material: **Clay** ☐ Pipe Lined
Invert Depth: **8.10** (ft.) Flow Characteristics: **Fast**
Deposits: ☒ None ☐ Mud ☐ Sludge ☐ Debris ☐ Grease
Silt Depth: **0** (in.) Deposits Extent:
Infiltration: **None** Pipe Seal Cond: **Sound**

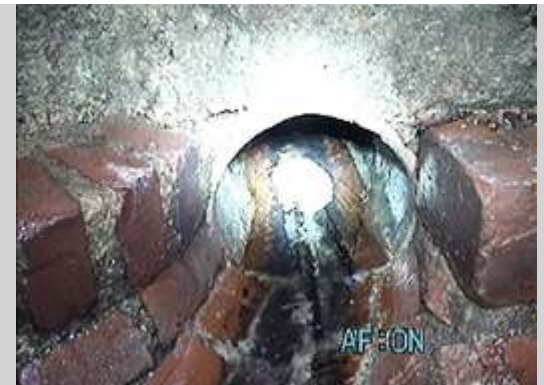
3 O'Clock Inflow

Pipe Height: **8.4** (in.) Rod and Bar (Angled)
Pipe Material: **Clay** ☐ Pipe Lined
Invert Depth: **8.00** (ft.) Flow Characteristics: **Fast**
Deposits: ☒ None ☐ Mud ☐ Sludge ☐ Debris ☐ Grease
Silt Depth: **0** (in.) Deposits Extent: **Light**
Infiltration: **None** Pipe Seal Cond: **Sound**

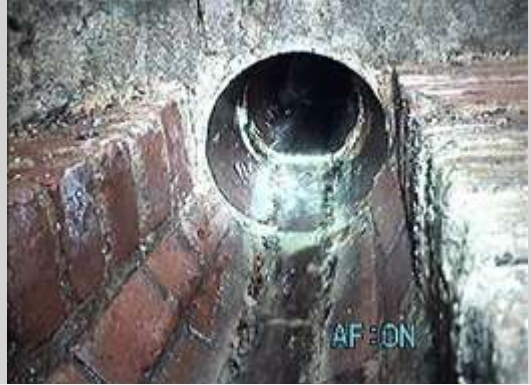
6 O'Clock Inflow

Pipe Height: **8.4** (in.) Rod and Bar (Angled)

Pipe Material: **Clay** ☐ Pipe Lined

Invert Depth: **7.90** (ft.) Flow Characteristics: **Fast**

Deposits: ☒ None ☐ Mud ☐ Sludge ☐ Debris ☐ Grease

Infiltration: **None** Pipe Seal Cond: **Sound**
